**Flood Control Project Maintenance
Levee Inspections**
LMA District Cover Sheet
Spring 2017 Levee Inspection Results

Sutter Maintenance Yard East Levee Sacramento River

Spring 2017 Levee Inspection Results

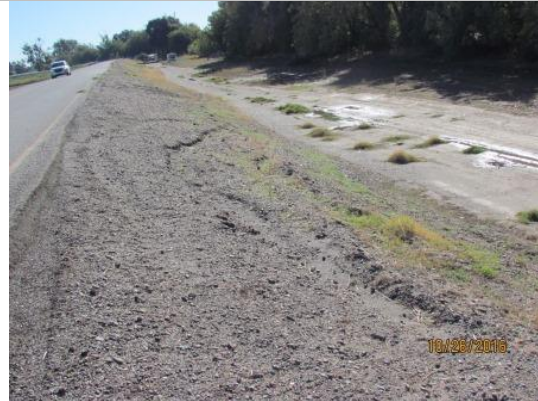
Photo 1 of 1 : SP_2017_ST0003_264_81_20170315_00025.jpg

LM Start	0.42	Rating **	M	Issue No.	81
LM End	0.42	Issue Type +	Ma	Location *	WS
Category	Earthen Levee			GPS Latitude/Longitude	
				Start	End
Item	Slope Stability			39.196483 °	39.196483 °
				-121.942228 °	-121.942228 °
DWR ID	DWR_ST0003_01_f_2016_81				
Comment Code					
S3 : Repair the levee slope damaged by vehicle traffic and prevent access where possible.					
Inspector Comment

View of the ruts along the waterside slope.

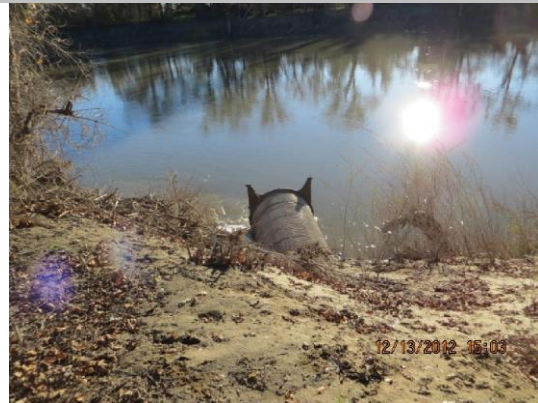
Photo 1 of 3 : UCIP_SP_2017_51650_46962.jpg

Comment Code					
Inspector Comment					
FS_ID:51650 DS_ID:17307 EP_NO: 9534 Repair Type: No Action Needed Crossing Status: Found UCIP Comments: 4/24/2017 Both sides of crossing were underwater during site visit. Will need to revisit after water levels drop. (DWR Sutter Yard- A Freitag)11/7/2016 Crossing appears to be in good condition. (DWR Sutter Yard- A Freitag)6/6/2016 Crossing appears to be in good condition.4/6/2015 Good Condition. No issues. Semi circle CMP half riser in inlet structure on LS. Inlet opeing has no trash rack, this may cause safety issue.6/30/2014 Same as last inspection.12/30/2013 Same as last inspection.7/29/2013 Same as last inspection. FIELD_STRUCT_DESC: [Butte Slough Drainage Structure] 78-inch drainage pipe of an unknown material through the levee, 3 feet below the crown. Flap gate on the waterside (WS). Corrugated metal pipe (CMP) half riser (in a semi-circle configuration) in the inlet structure on the landside (LS). (Automatic Board Order (ABO) issued as Permit No. 9534, 1974 - Caleta). [Additional Reference(s): DWR Levee Log, 2002. USACE Sacramento O&M Manual 136, March 1960 (HLM 0.44)]. FS Date: 4/26/2017 9:46:51 AM

Waterside view: overview towards CMP sewer pipe

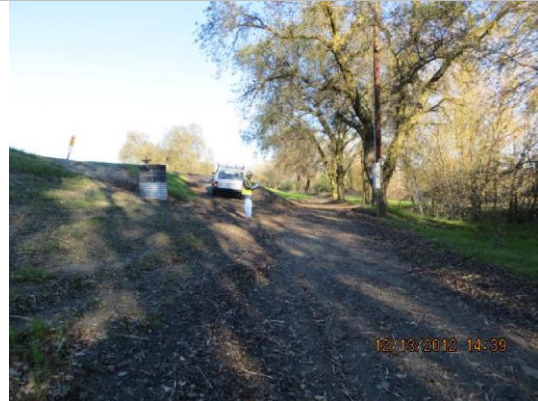
Photo 1 of 3 : UCIP_SP_2017_51653_46983.jpg

FS_ID:51653
DS_ID:17319
EP_NO: 9527
Repair Type: Urgent
Crossing Status: Found
UCIP Comments: 4/24/2017 LS slope dsamage is still present. No repairs have been made to this crossing yet. (DWR Sutter Yard- AFreitag)11/7/2016 No LS repairs have been made yet. (DWR Sutter Yard- AFreitag)6/6/2016 New flow meter installed on WS. Walkway to access the pump is overgrown with vegetation and not accessible. (DWR Sutter Yard - afreitag) 4/5/2016 Caved-in slope on landside (LS) not yet repaired. Leaky pipe marker gone. Per Bob Duffey (DWR FPIIB inspector), pipe will be replaced by owner next year. If not, will go to CVFPB enforcement. (DWR UCIP - kfazel)4/6/2015 Pipe leaks during times of High water. Slope damage still present. Needs a more detailed inspection to find the leak. (DWR Sutter Yard - afreitag)6/30/2014 Same as last inspection. (DWR Sutter Yard - afreitag)12/30/2013 Same as last inspection. (DWR Sutter Yard - afreitag)7/29/2013 Pipe does not appear to be abandoned. On the WS it appears that a smaller pipe was sleeved into the 18in. Pipe and then the difference capped and welded. Pump was not running at time of inspection but LS ditch near outlet was wet. LS slope damage and leaky pipe marker are still present. (DWR Sutter Yard - afreitag)12/13/2012 Abandoned and plugged/capped steel pipe on WS berm. DWR leaky pipe marker on LS (12-3). Slope failure on LS. Needs capping of LS steel pipe after detailed investigation. (DWR UCIP - pamatya)

Waterside view: overview

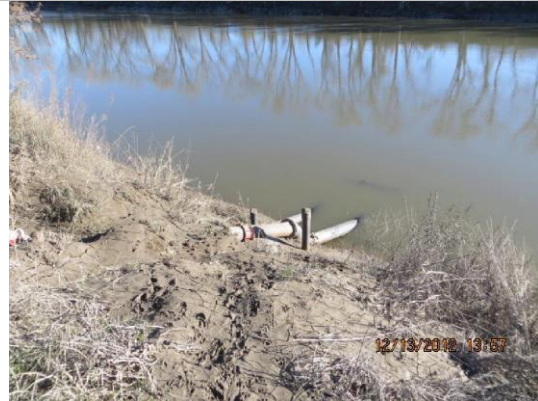
Photo 1 of 3 : UCIP_SP_2017_51657_47004.jpg

FS_ID:51657
DS_ID:17321
EP_NO: 9543
Repair Type: Urgent
Crossing Status: Found
UCIP Comments: 4/24/2017 Abandoned and needs to be done so properly. Vegetation was to thick on the LS slope to see and sloughing or slope damage. (DWR Sutter Yard- AFreitag)11/7/2016 Abandoned. (DWR Sutter Yard- AFreitag)6/17/2016 Abandoned crossing. (DWR Sutter Yard - afreitag)4/5/2016 Appears abandoned and should be done so properly. LS levee slope has a slight but sudden drop (could be due to improper compaction). Dense vegetation on LS prevented visibility of sloughing or other damage to levee. Could not locate leaky pipe marker. Per Bryan Reniff of Sutter Yard, marker was previously installed due to a high water event, not leaky pipe. Appears repair work to levee performed but unclear of extent. Gate valve on WS is bent and damaged, appears abandoned. Crossing a good candidate for video inspection. (DWR UCIP - kfazel)4/6/2015 Sloughing LS slope and river bank. DWR marking for leaky pipe. (DWR Sutter Yard - afreitag)6/30/2014 Same as last inspection. (DWR Sutter Yard - afreitag)12/30/2013 Same as last inspection. (DWR Sutter Yard - afreitag)7/29/2013 Same as last inspection. (DWR Sutter Yard - afreitag)12/13/2012 Sloughing LS slope and river bank. DWR marking for leaky pipe. (DWR UCIP - pamatya)

Waterside view: pipe @river bank

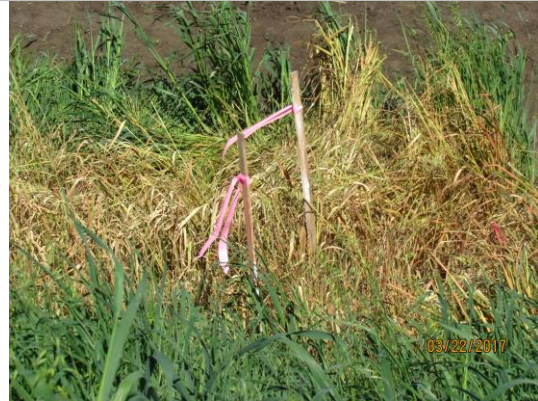
Photo 1 of 1 : SP_2017_ST0003_264_117_20170329_00182.jpg

View of a open pipe at this location.

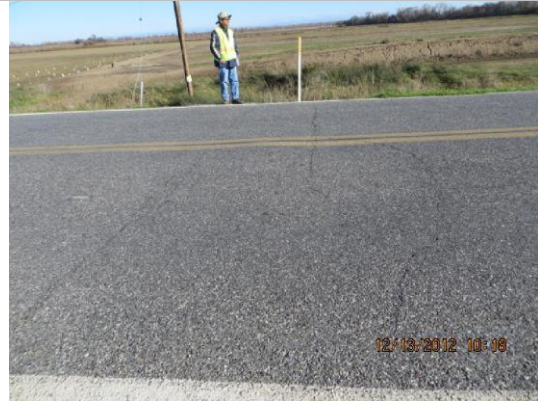
Photo 1 of 3 : UCIP_SP_2017_51674_47068.jpg

Crown view: transverse cracks on levee road.

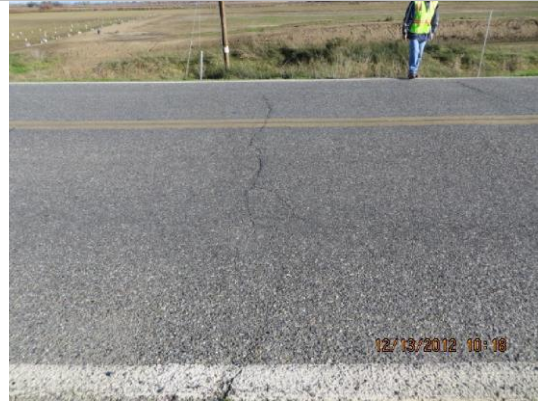
Photo 1 of 3 : UCIP_SP_2017_51676_47087.jpg

Crown view: transverse crack on levee road

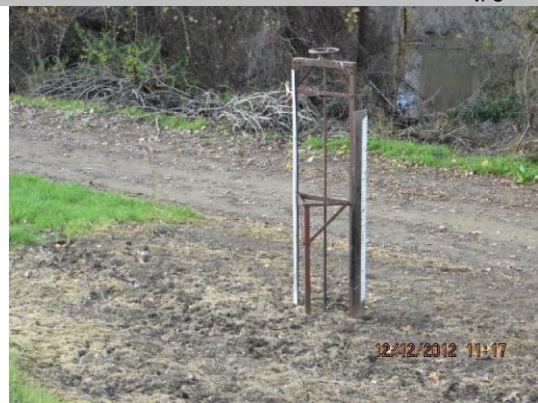
Photo 2 of 3 : UCIP_SP_2017_51726_47209.jpg

Waterside view: buried slide gate

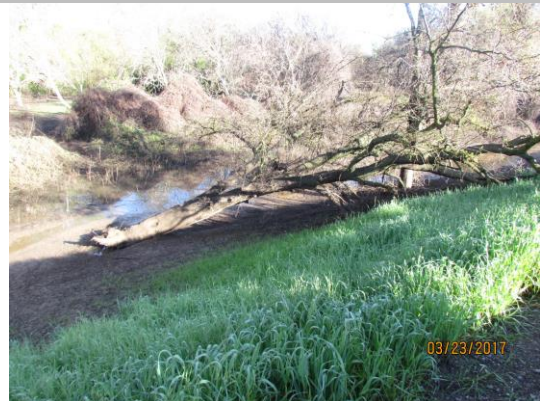
Photo 1 of 1 : SP_2017_ST0003_264_120_20170329_00184.jpg

View of the tree along the waterside slope & toe.

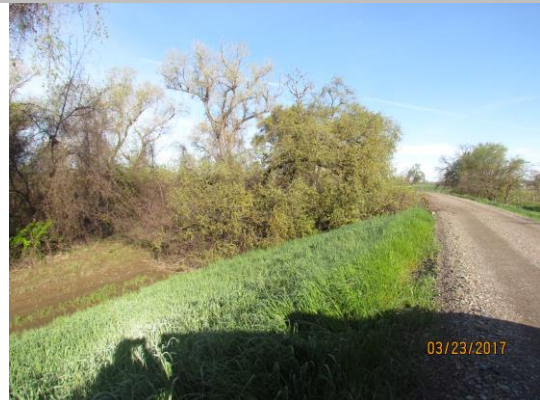
Photo 1 of 1 : SP_2017_ST0003_264_125_20170329_00185.jpg

View of the tree on the waterside slope and toe.

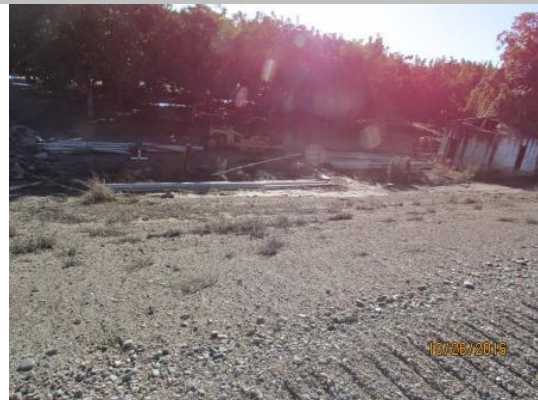
Photo 1 of 1 : SP_2017_ST0003_264_76_20170315_00022.jpg

View of the ag equipment along the landside toe.

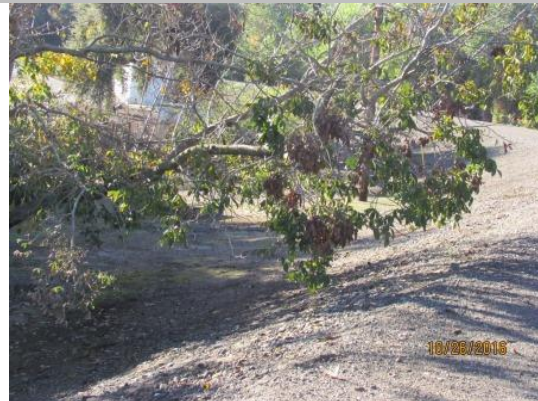
Photo 1 of 1 : SP_2017_ST0003_264_73_20170315_00019.jpg

View of a tree limb hanging over the landside slope.

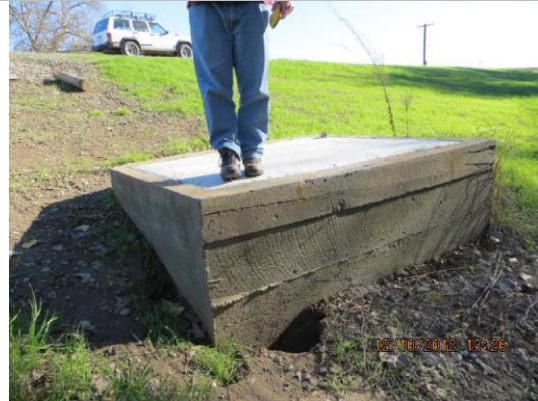
Photo 3 of 3 : UCIP_SP_2017_51753_47366.jpg

Waterside view: plugged concrete surge box

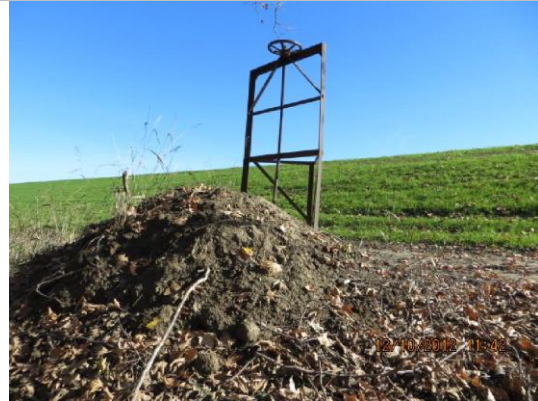
Photo 3 of 3 : UCIP_SP_2017_51760_47378.jpg

Waterside view: silt and debris in front of slide gate

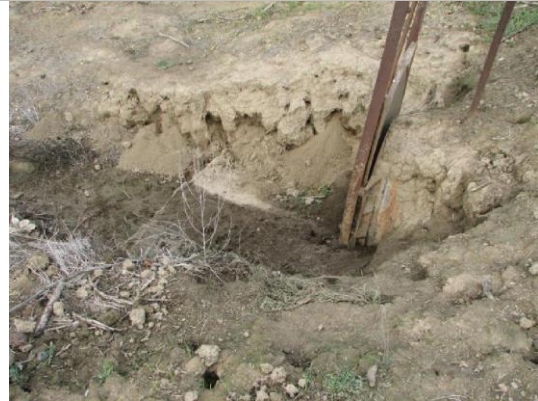
Photo 3 of 3 : UCIP_SP_2017_51770_47403.jpg

Waterside view: sloughing at outlet pipe

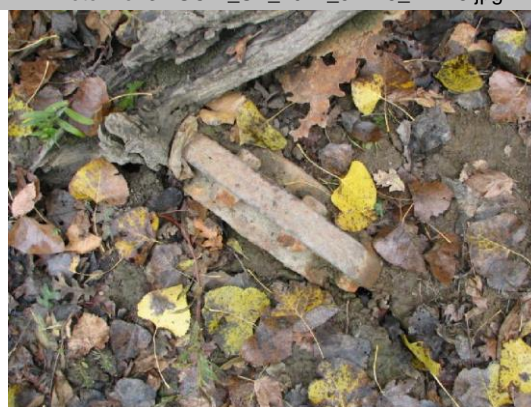
Photo 2 of 3 : UCIP_SP_2017_51775_47448.jpg

Waterside view: abandoned and ruined pipe

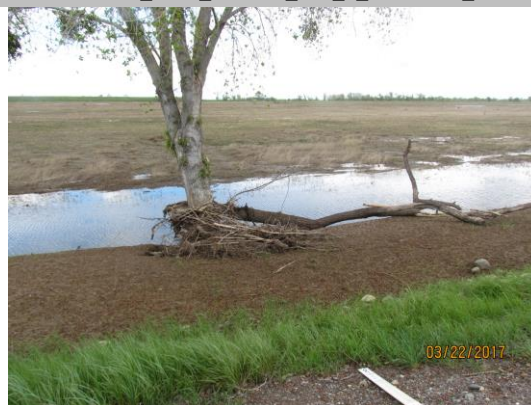
Photo 1 of 1 : SP_2017_ST0003_265_8_20170329_00009.jpg

View of the debris along the waterside toe.

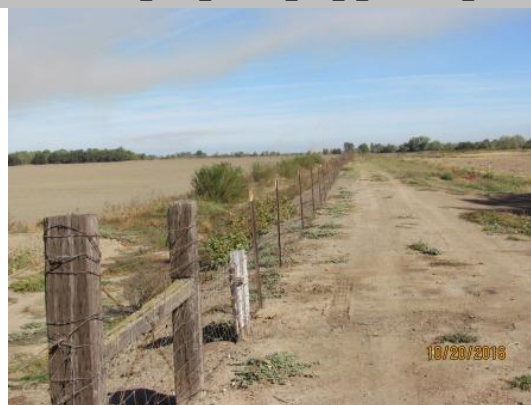
Photo 1 of 1 : SP_2017_ST0003_268_1_20170315_00001.jpg

View of the fence obstructing access.
